Five-Year Review Report

Third Five-Year Review Report for Hollingsworth Solderless Terminal Company Ft. Lauderdale Broward County, Florida

December 2005

United States Environmental Protection Agency
Region 4
Athens, Georgia

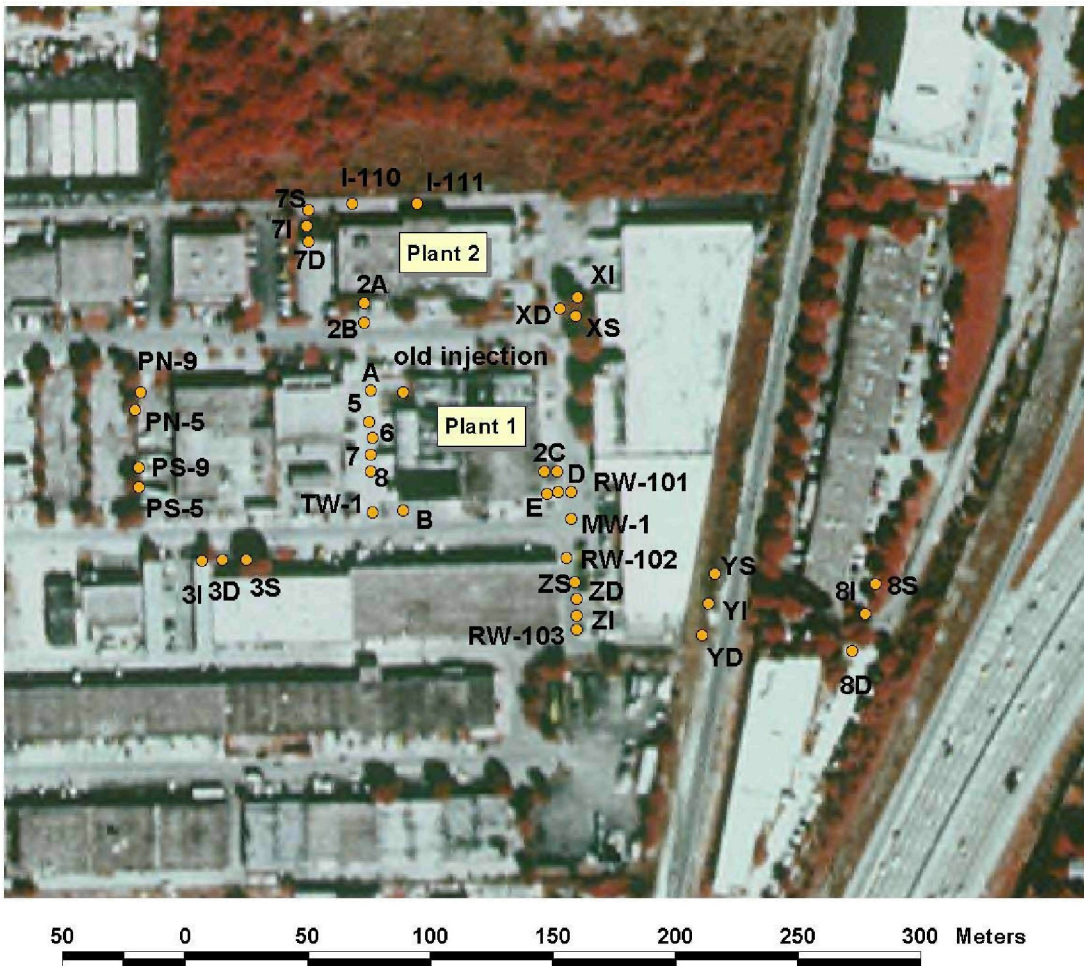
Figure 2: HSTC Historic Groundwater Monitoring

number of 20 monitoring wells. These wells were not found during this third Five-Year Review. Monitoring well locations are shown on Figure 2. Limited well abandonment has taken place over the history of the HSTC Site. For example, monitoring wells YD, XI, and A were previously abandoned.

Groundwater monitoring locations approximate. Locations derived through inspection of Site Layout Map found in First Five-Year Review report.

Injection Well location approximate and not found during Second or Third Five-Year Review.
